ANNUAL REPORT FOR 2003

New Light Creek Mitigation Site
Wake County
Project No. 8.U401721
TIP No. R-2000 WM

Prepared By:
Office of Natural Environment & Roadside Environmental Unit
North Carolina Department of Transportation
December 2003

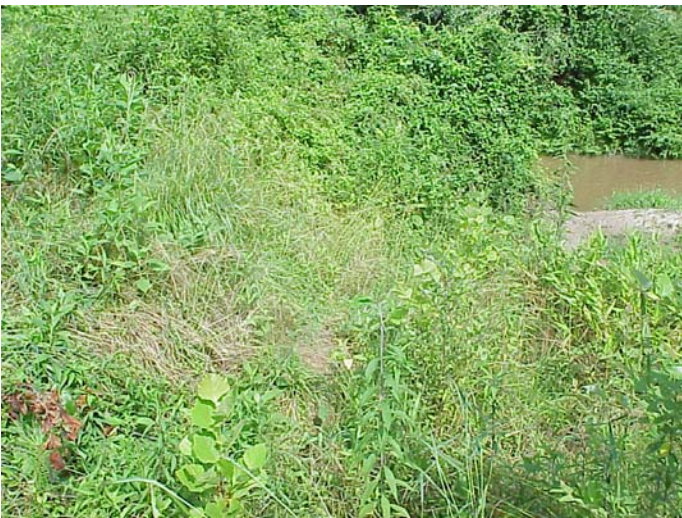
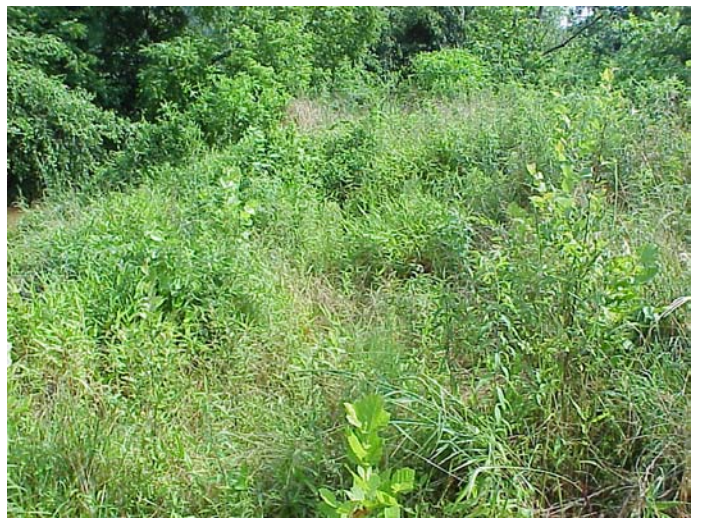
NCDOT and USACE personnel inspected the washout along the streambank in June 2000. It was agreed that NCDOT would repair the washout. This work was not done. A site inspection in September 2000 revealed this washout to be stabilizing on its own. NCDOT has continued to monitor this area to determine if this slope will stabilize given time. The streambank was inspected and photographed during the 2003-monitoring visit and no other signs of erosion were observed (see photos 5 and 6).
